REPORT OF AF AIRCRAFT ACCIDENT

1. PLACE OF ACCIDENT: State, county, nearest town—Distance and direction to accident
Tennessee, Carroll, Huntington, 1/4 MI W.

1. AIRCRAFT No.
52-5894 A

2. TYPE, MODEL, SERIES AND BLOCK No.
C-119G

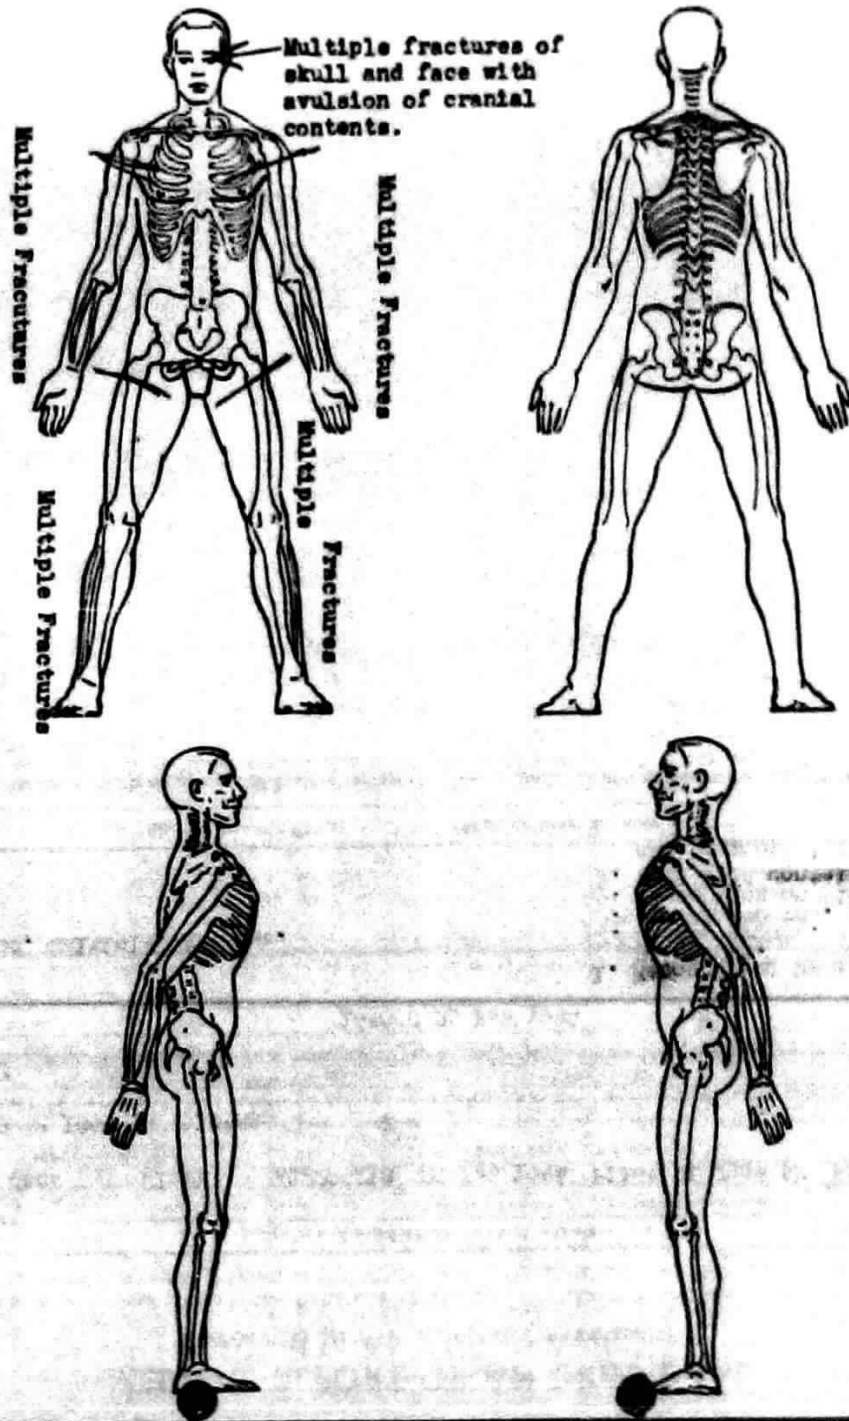
Multiple fractures of skull and face with avulsion of cranial contents.

Multiple Fractures

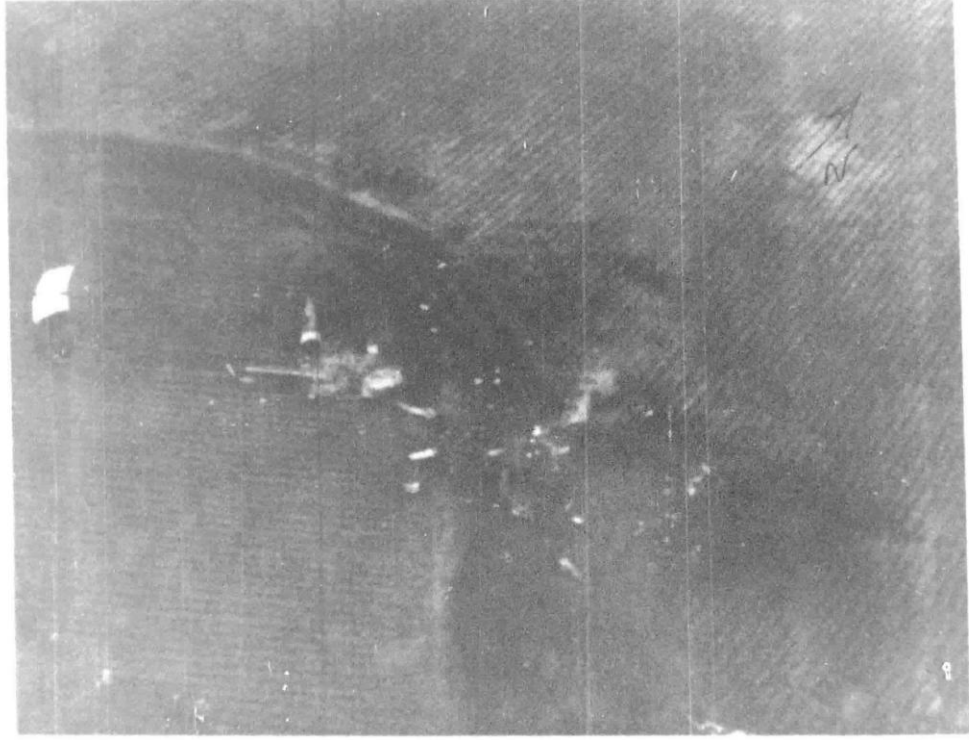
5

Aerial view looking N.W.

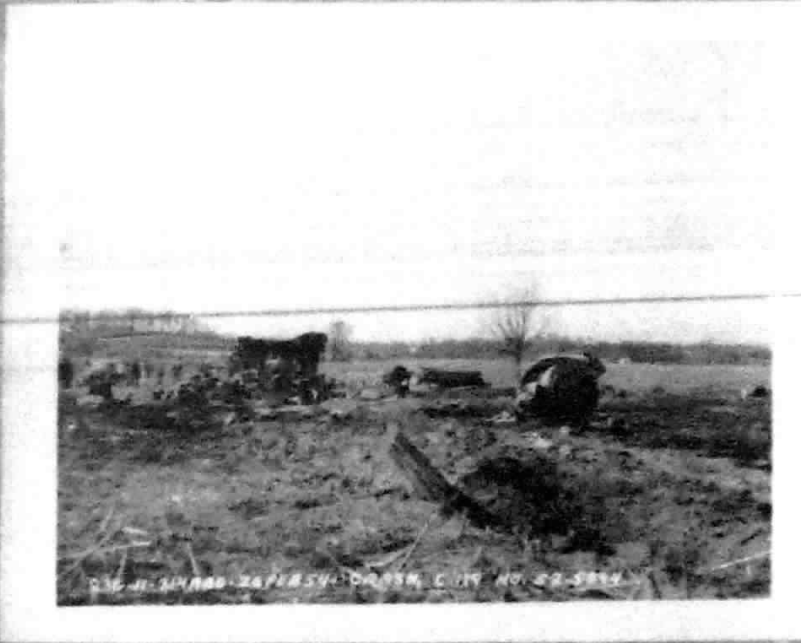
View of 1st impact pt.
looking west

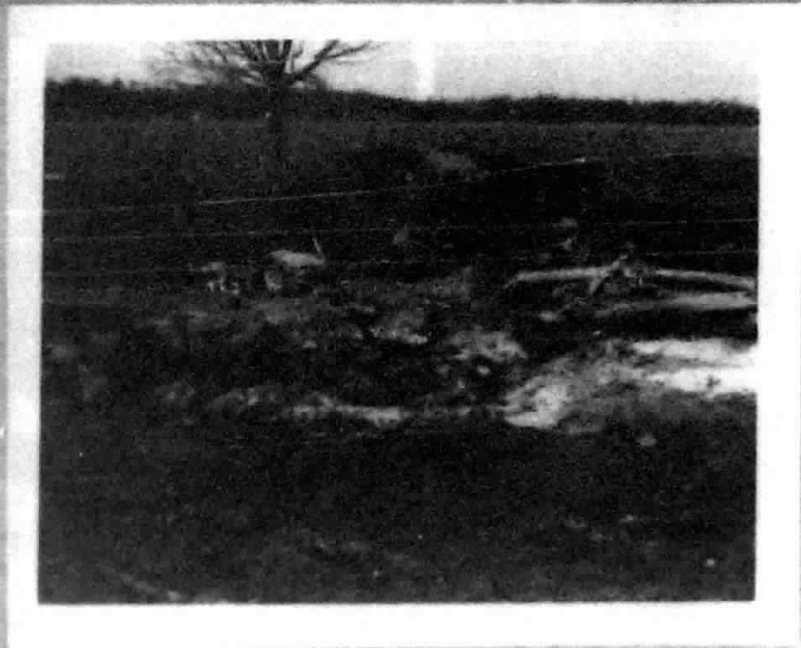
2.

Remains of rt boom, rt
ldg. gear, burned inboard
section of wing and nec-
elle end of outboard sec-
tion of rt wing

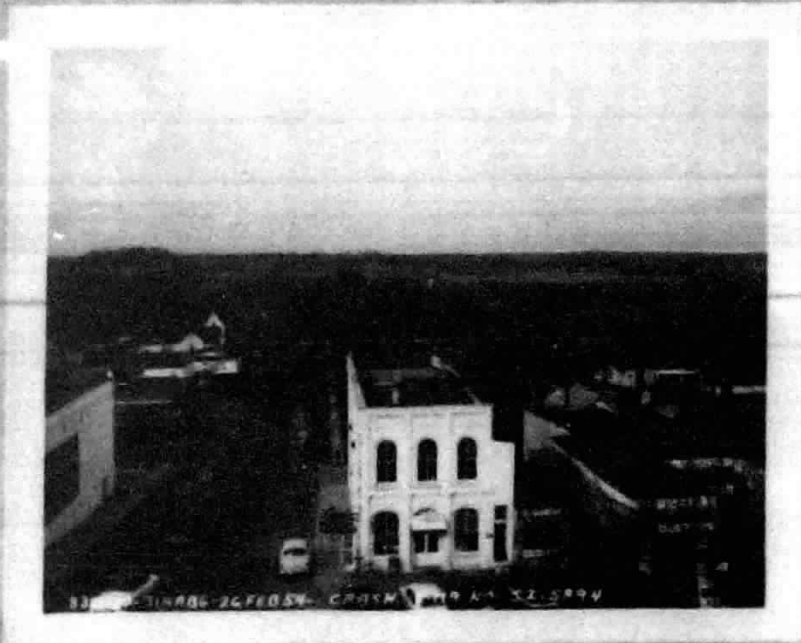
9	Roof of Electric Company - 8 ft section of right wing from nacelle outboard. Includes fuel filler cap (top side of wing).
10	Edge of road - 20 feet of horizontal stabilizer. Right side complete to connection points.
11	Left rear jump door - cargo door bar found sticking roof of house. 6 ft of inboard section of right aileron, outboard end inward.
12	Small portion of skin located around inspection plate W-18L bottom side of wing and W-6L top side of wing.
13	Left clam shell door.

Section of top right wing
Top of "TEa Room", facing
west. Position 4 & h map.

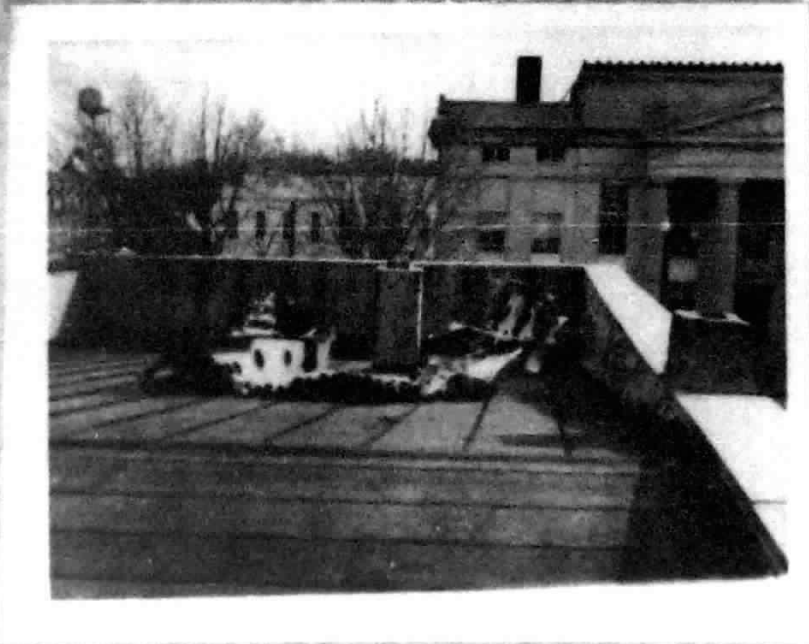
Close up of right wing
section

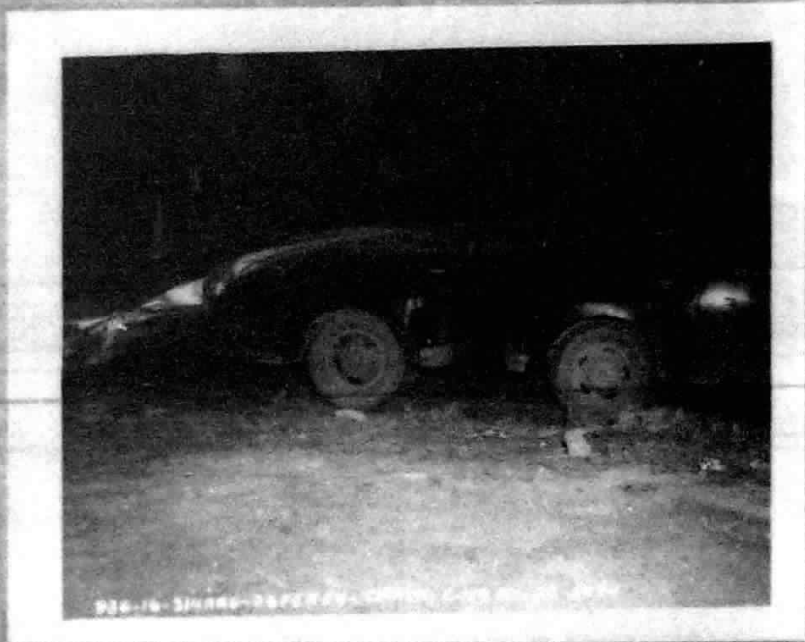
Horizontal stabiliser
leading edge of surface sho
showing. Pos 10 on map.

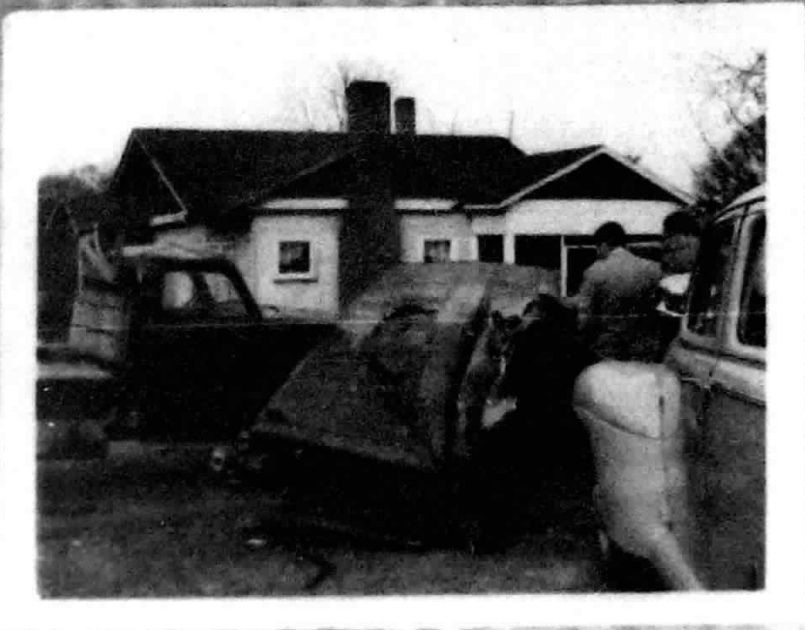
Right side of Horizontal
stabiliser

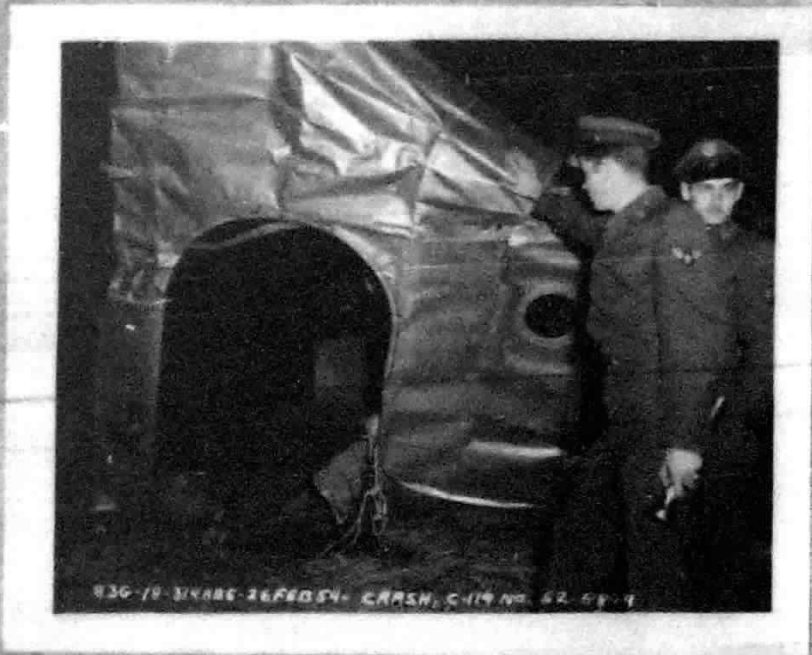
Left clam shell door.
Pos. 13 on map

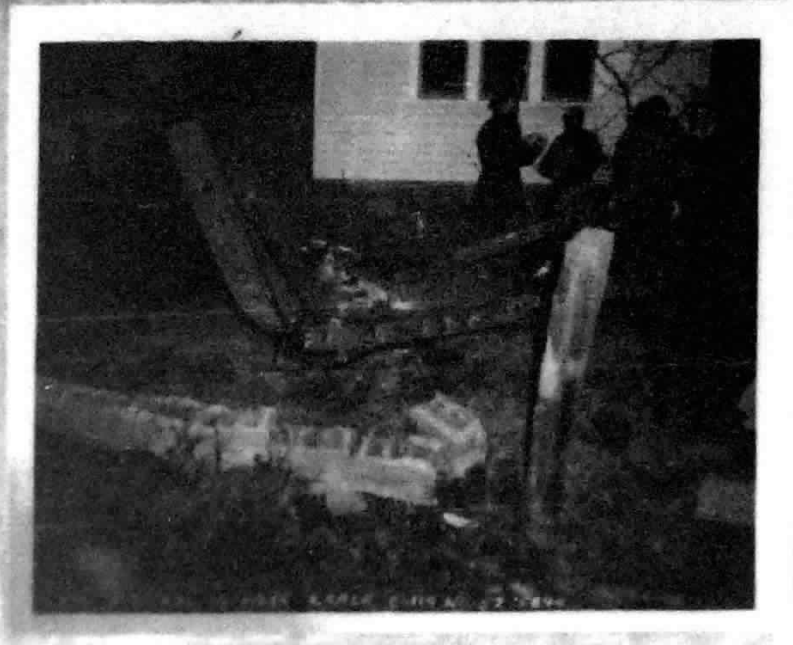
Left clam shell door in
position where it was
found.

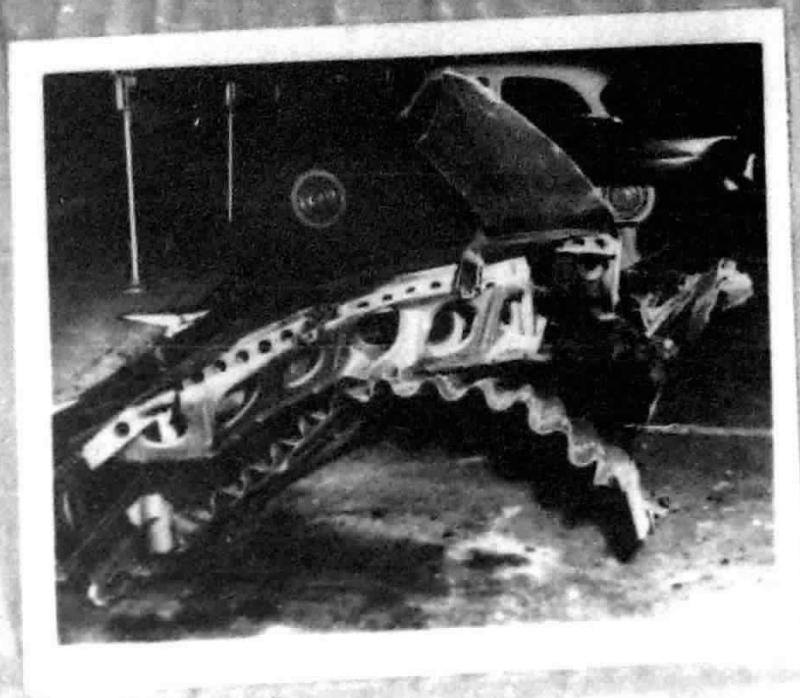
Section of right wing
from tip inboard 16 feet.
Pos.2 on map.

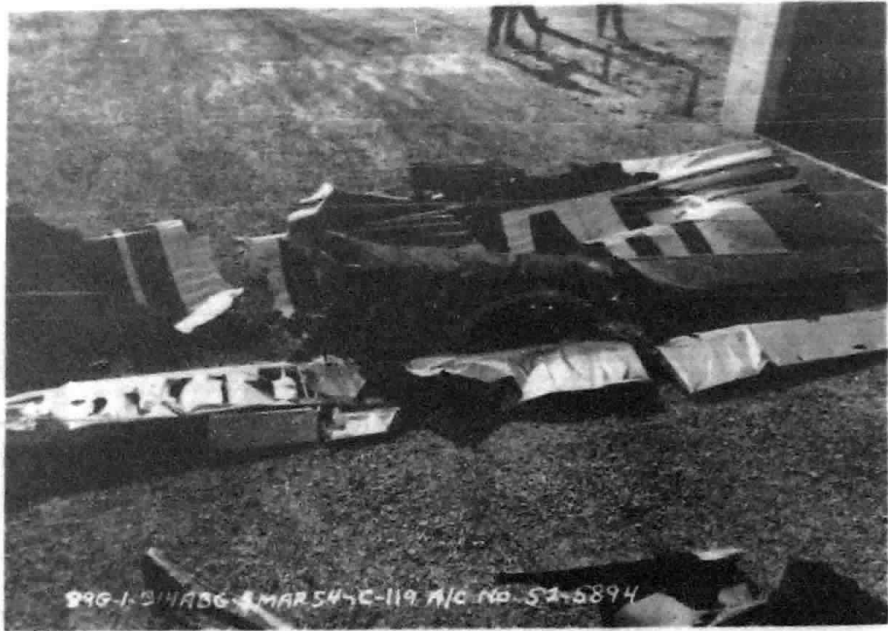
1. The wing indicated that an extremely high torsional moment had been applied.
2. Evidence of high positive bending was also indicated by the deformations that had occurred, that is, compression buckling of the upper surface corrugation.
3. The wing failed, apparently simultaneously, in four separate and distinct places in what was probably a combined condition of high torque and bending.
4. No evidence of fatigue was apparent in the portion of the right wing which could be pieced together. All fittings and spar caps examined on the right wing indicated tension and/or tension and shear type failures with clean breaks.
5. A spot check of skin and spar web thicknesses indicated conformance with blueprint requirements.

Trailing edge of reconstructed right outboard wing

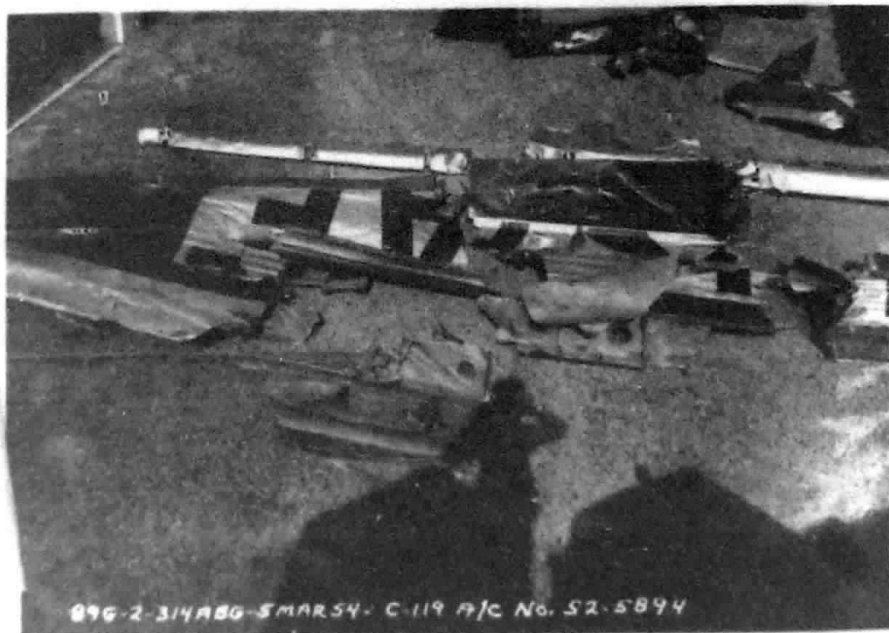
Leading edge of reconstructed right outboard wing.
